APPENDIX B

Site Reconnaissance

Date: Thursday 28 June 2007
Staff: Brian Myller (Waterstone), Richard Taylor (Waterstone)
Project: Proposed FBI Denver Division Office Building
Site Address: Former Stapleton Airport (East of 7805 East 35th Avenue)
Site Manager: n/a
Access Limitations: Site was not accessible to due active asbestos remediation. Site reconnaissance was limited to visual inspection from the western Site boundary and from the nearest accessible locations in the north, east and south. The eastern part of the site was not clearly visible to us.

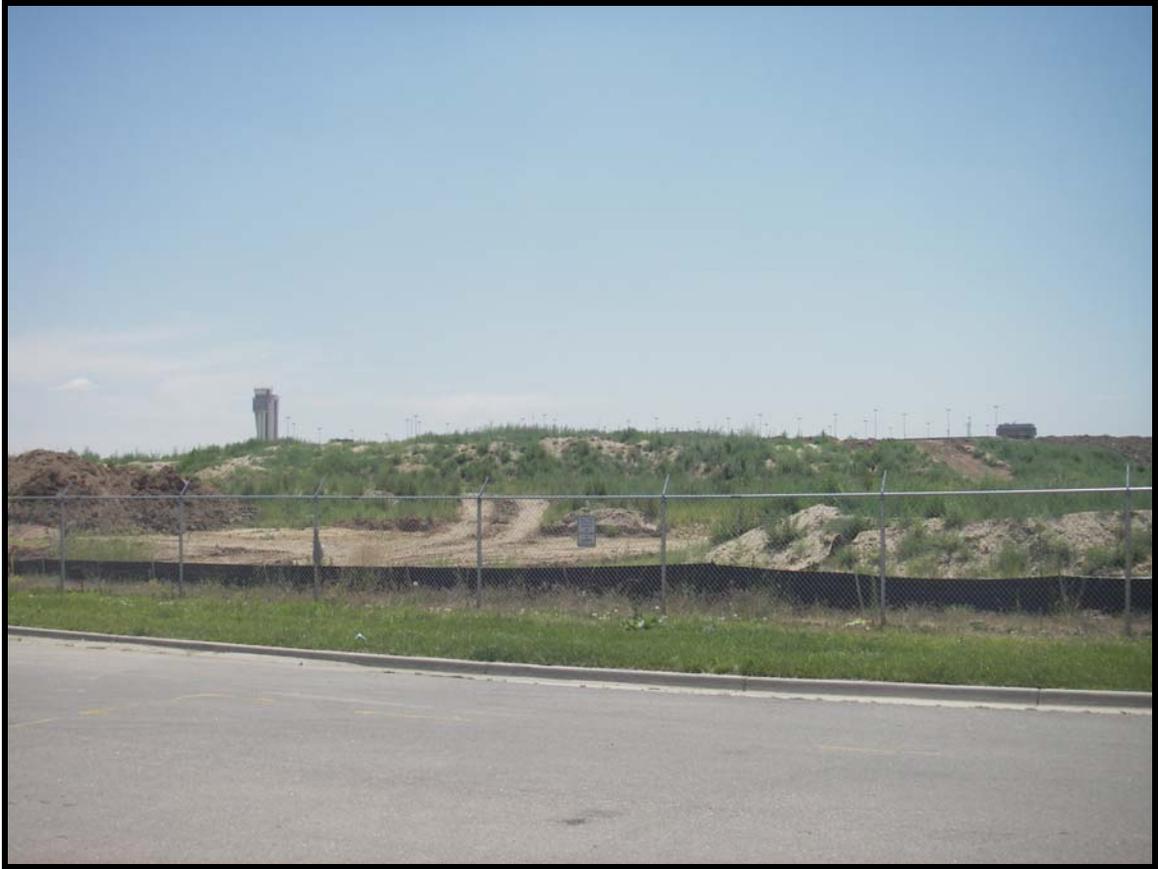
23

Looking south from the south-western corner of the site.

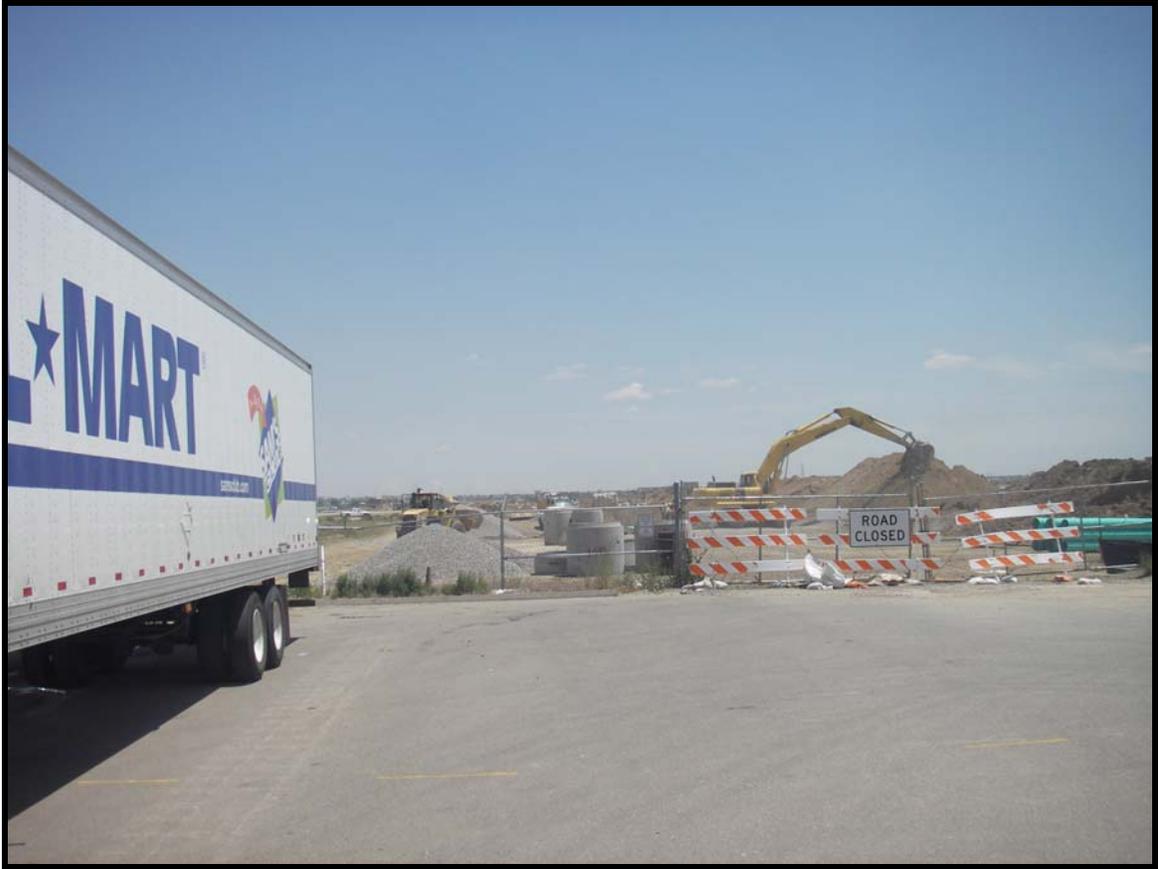
24

Looking to the east along 35th Avenue from the south-western corner of the site.

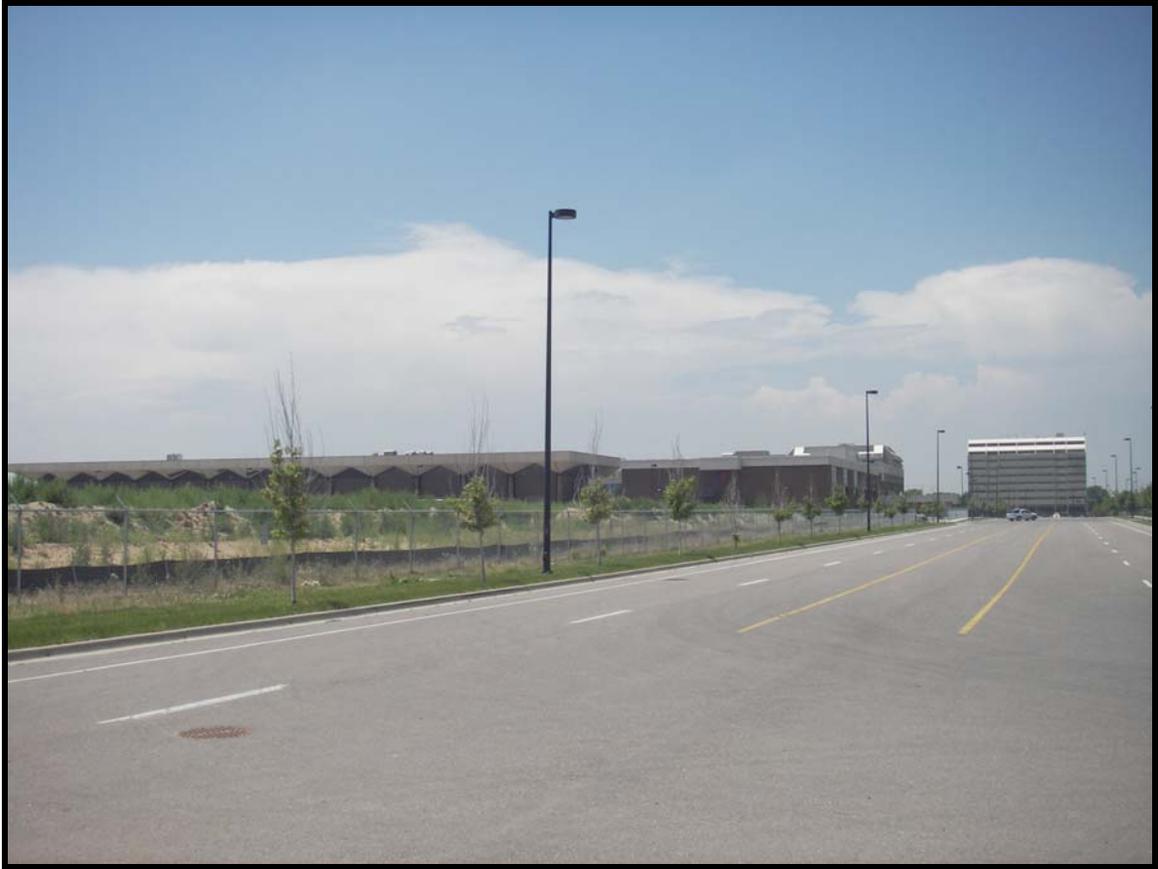
25

Looking to the west along 35th Avenue from the south-western corner of the site.

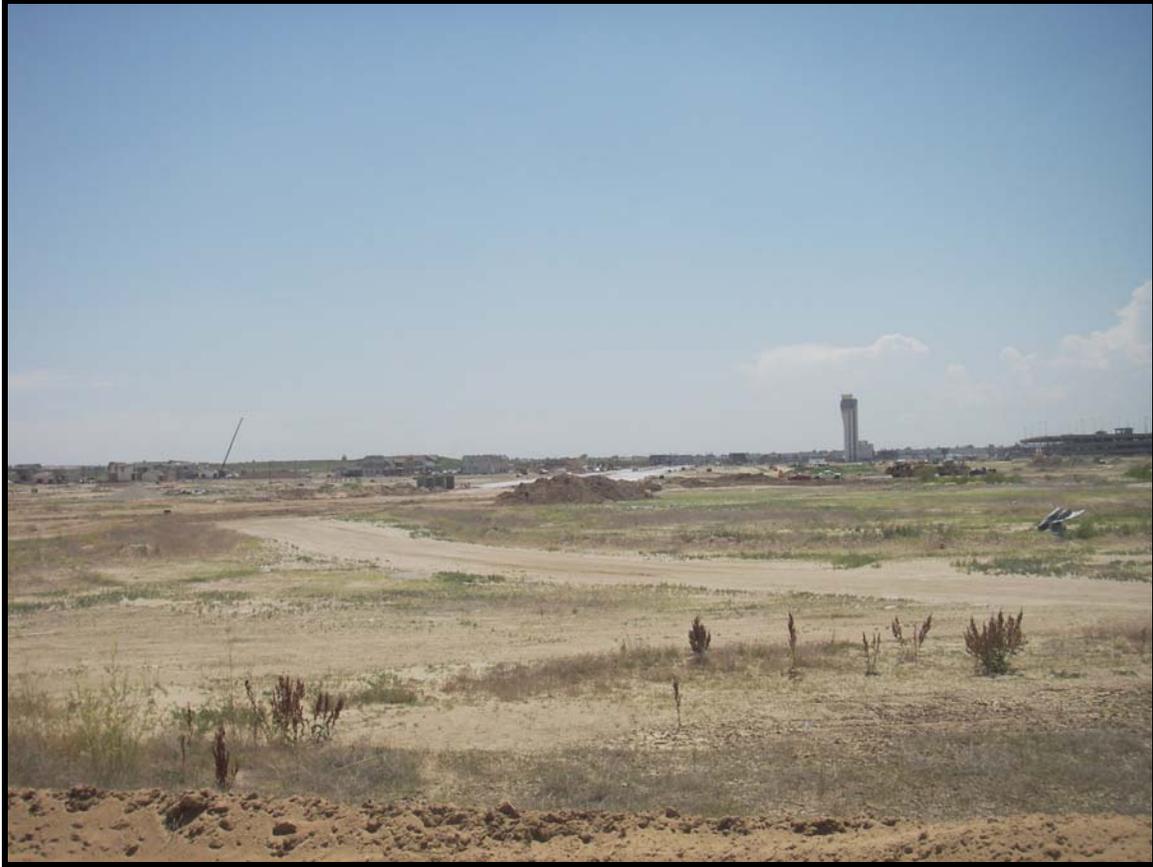
26
Looking to the south from East Smith Road north of the Site.

This is the nearest we could get to the Site from the north. The photograph shows the development activity to the east of the Site.

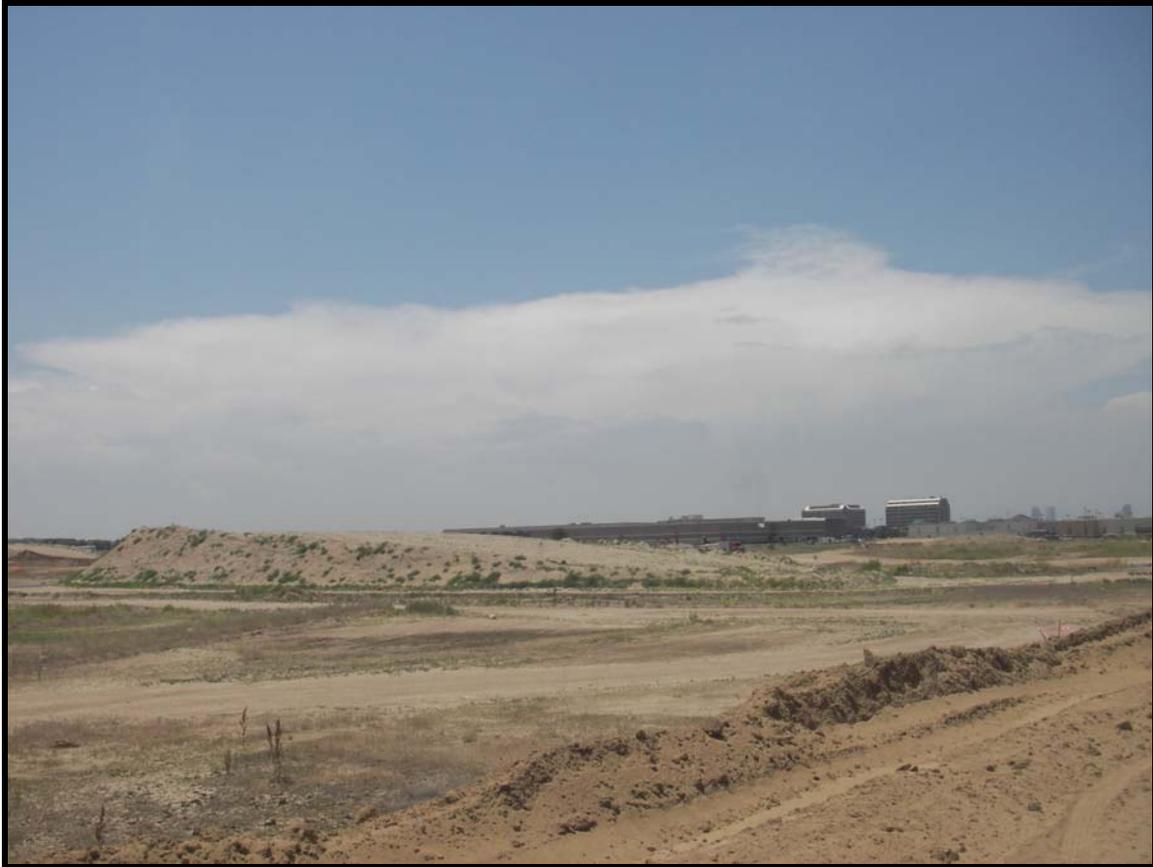
27

Looking to the south-west from East Smith Road north of the Site.

Looking south-west towards the Site. The building in the background is the adjacent Sam's Club property. The Site is behind the soil pile. The photograph shows the disturbed nature of the land at the Site and in the general vicinity.

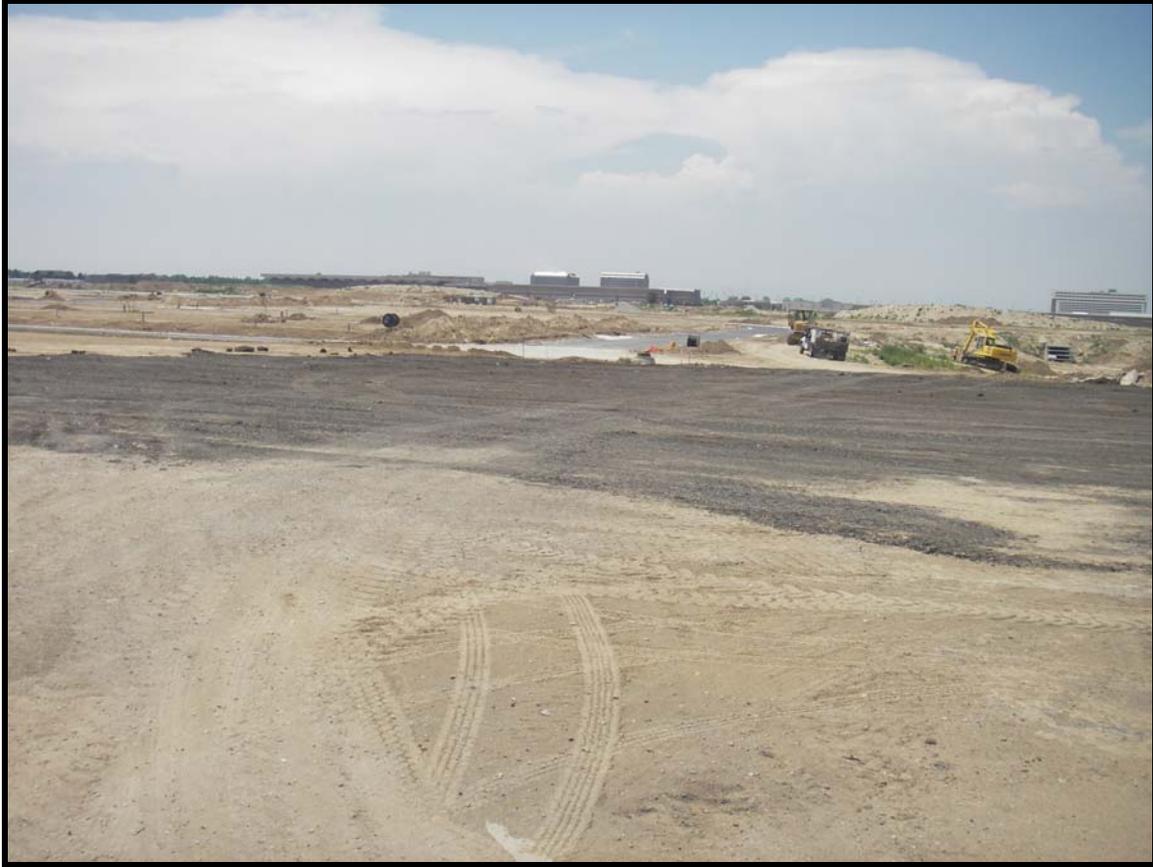
28

Looking to the west / south-west from Yosemite Parkway east of the site.

This is the nearest we could get to the Site from the east. The photograph shows the development activity to the east of the Site. The development is zoned Office and R&D. The area behind the camera is zoned Residential and construction of homes is underway.
